**GROUND
PENETRATING
RADAR
SYSTEMS, INC.**

Re: Summary of Void Inspection on 4.8 Mile Trolley Loop.

Aerial Overview of Scan Area

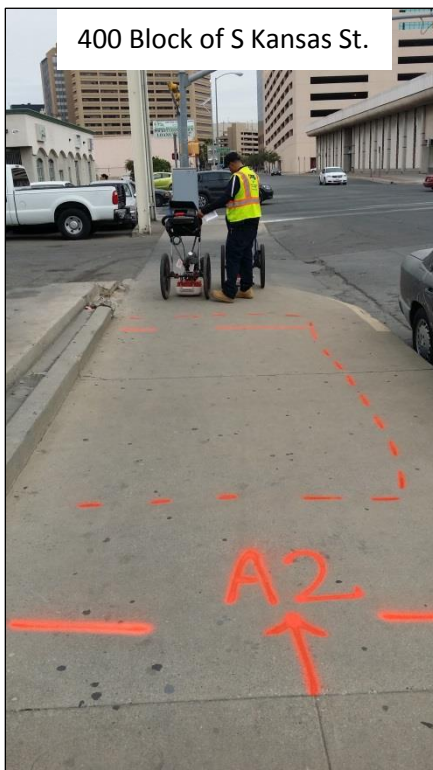
The type of reaction seen here is indicative of (and almost certainly is) air space. We can see that we are near the opening of a utility vault and the data confirms it.

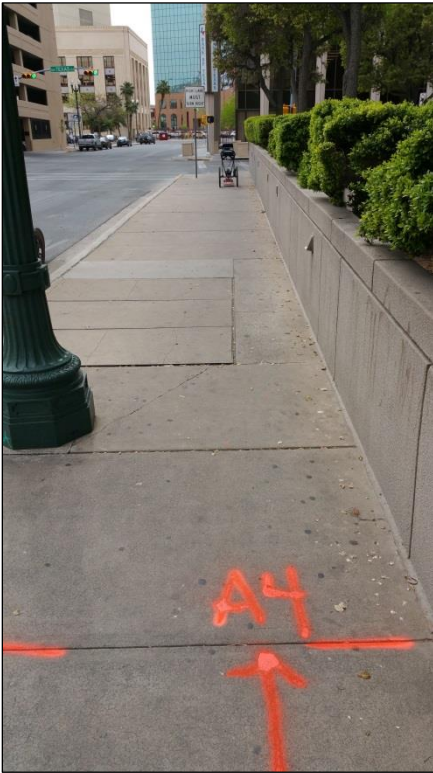
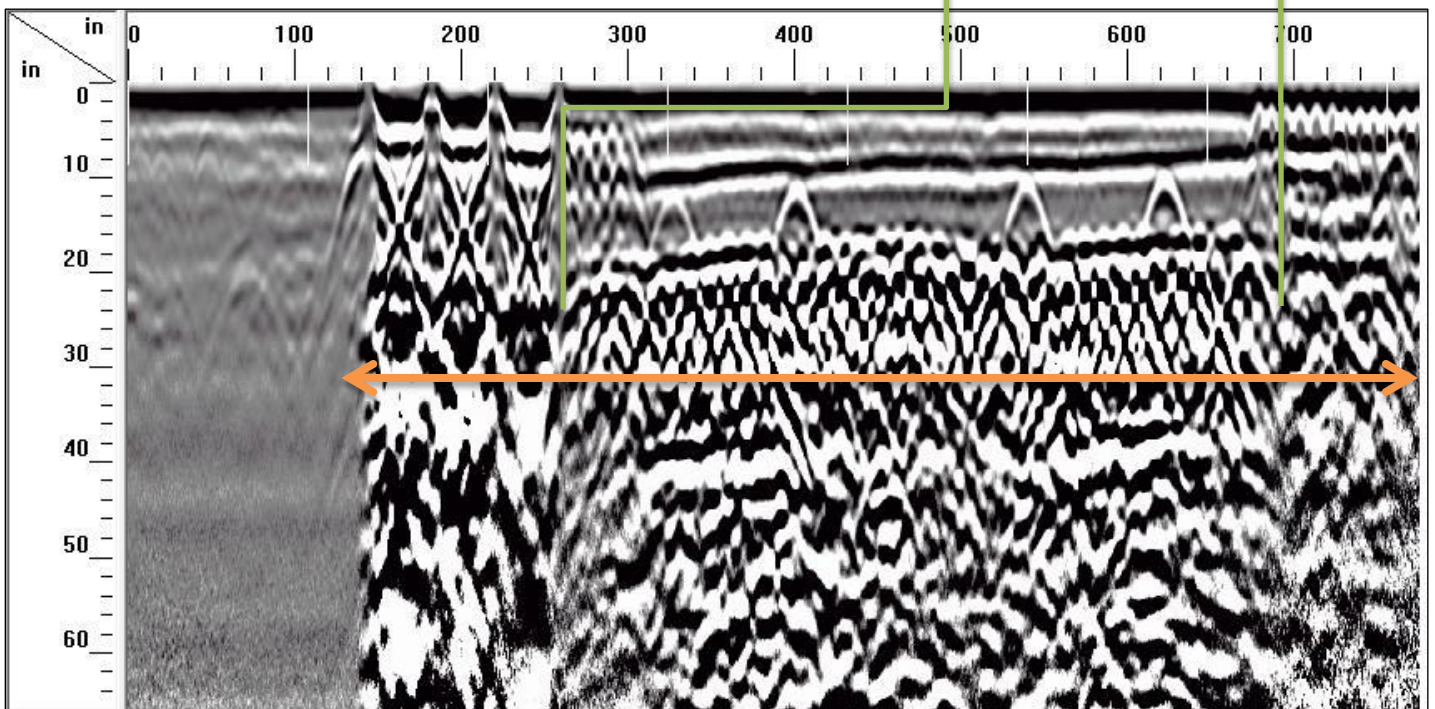
Another type of reaction that is indicative of (and almost certainly is) air space.

There appears to be two separate strata below the surface concrete before the void space appears.

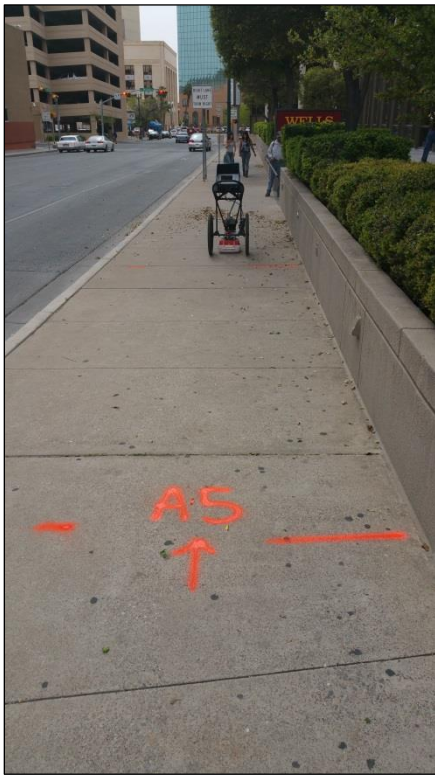
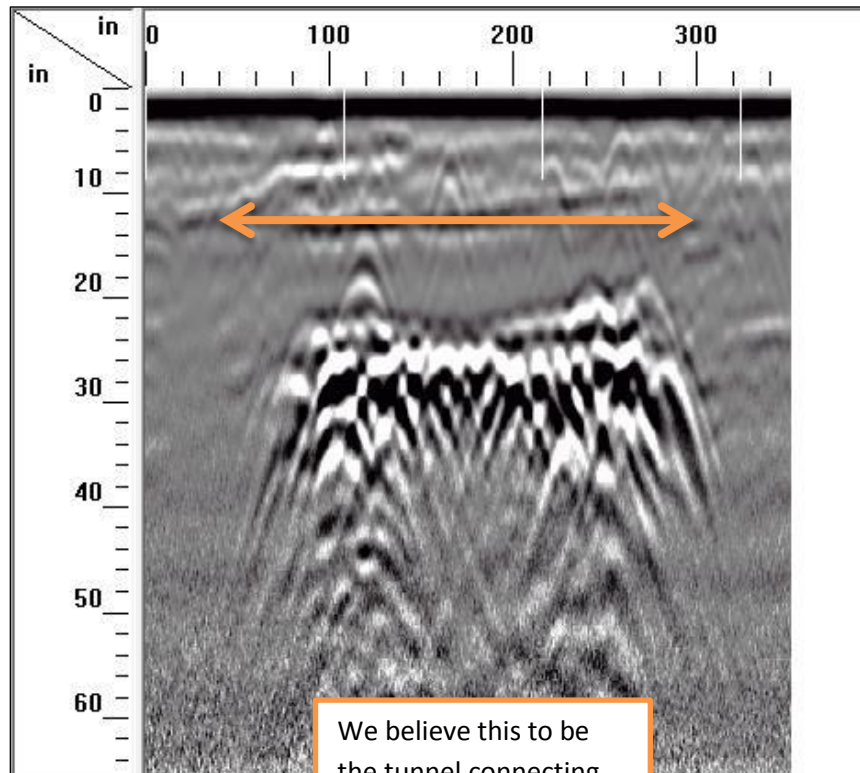
Wells Fargo Building

We believe this to be the tunnel connecting the parking garage to the Wells Fargo building.

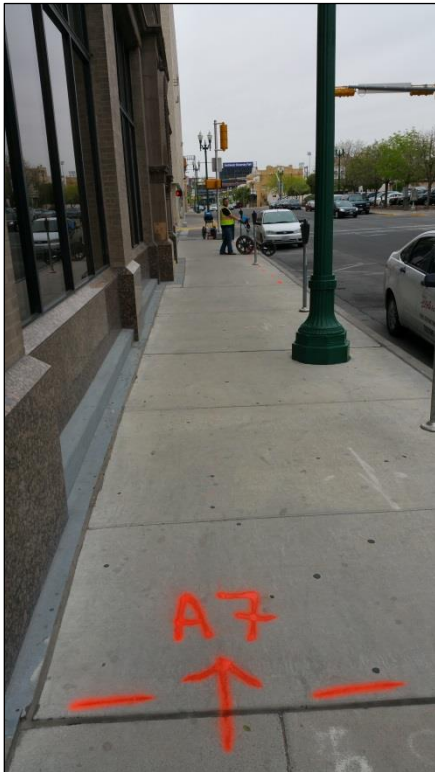
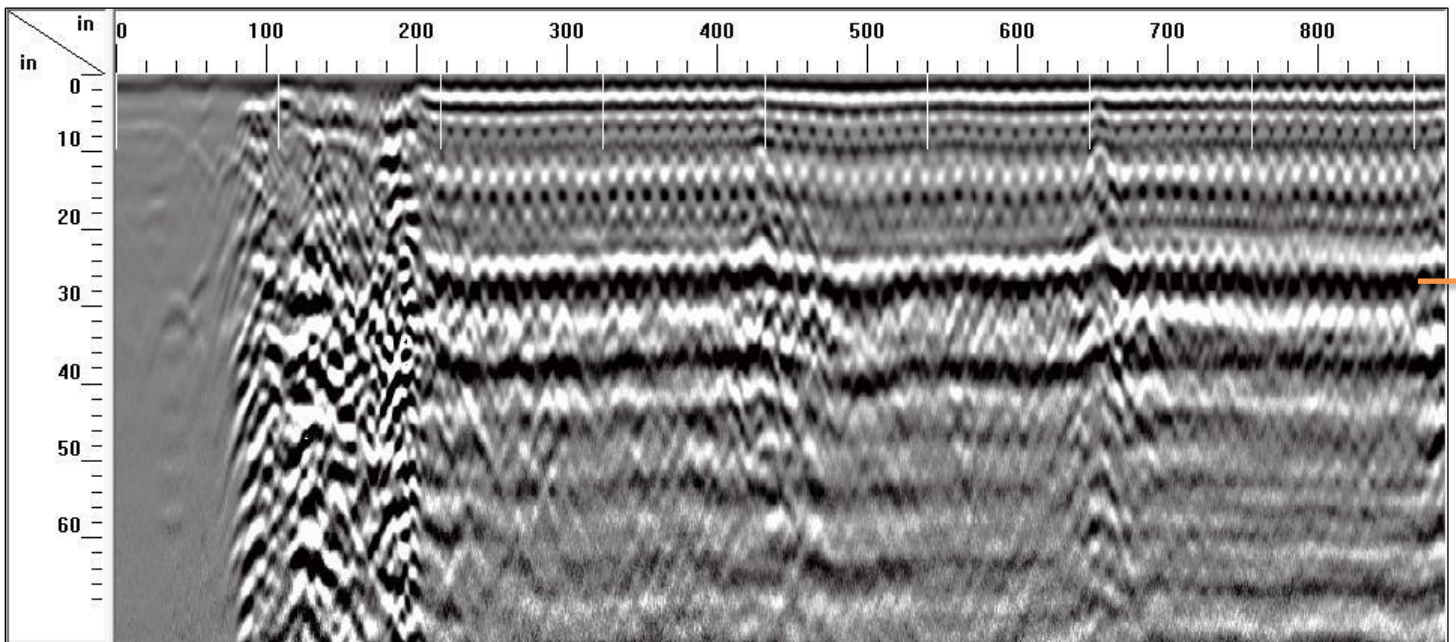
Banamex Building
416 N Stanton St.

This reaction spans the front of the building and extends to the parking meters. Void reaction at 24" depth.

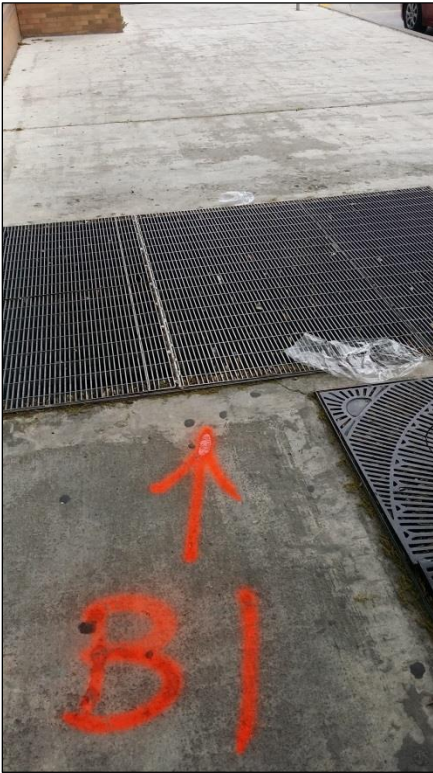
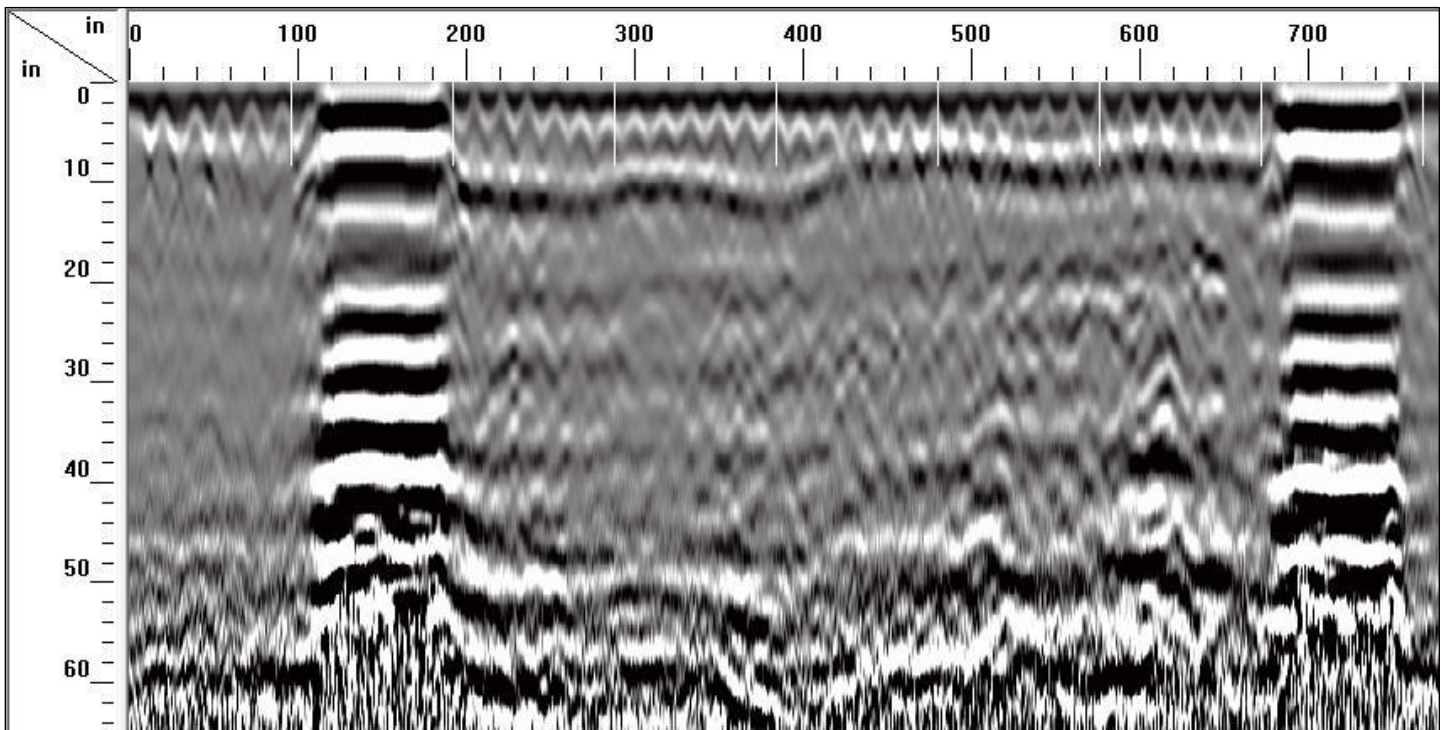
500 E San Antonio Ave.

This reaction spans the front of the building and by looking down through the vault covering you can see that is expansive.

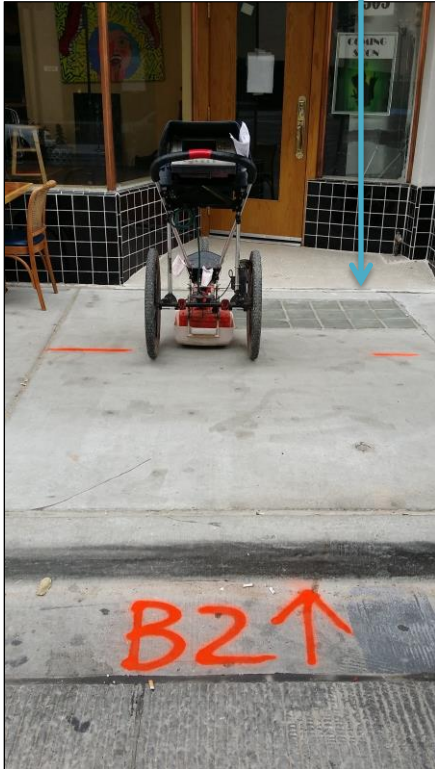
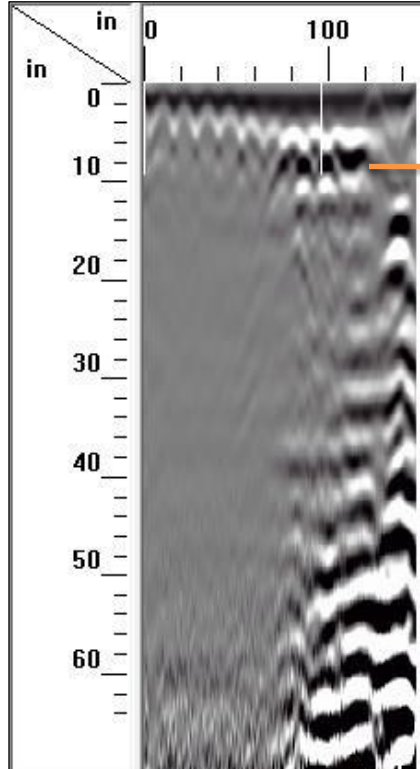
The Pizza Joint Downtown
500 N Stanton St.

Glass block in the concrete. You can see that there is basement space below.

Void space

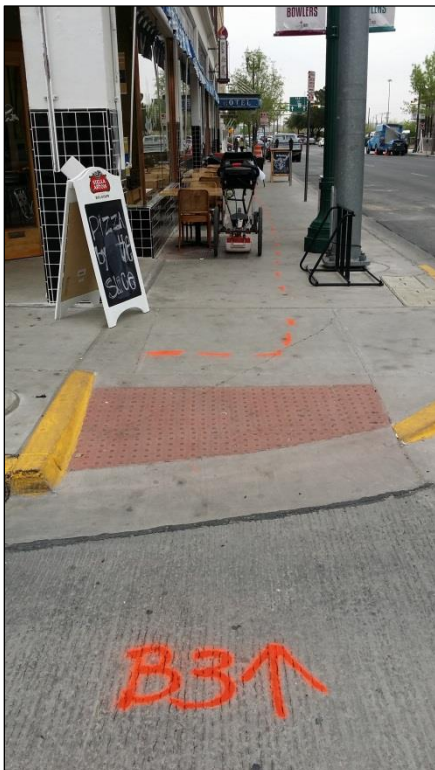
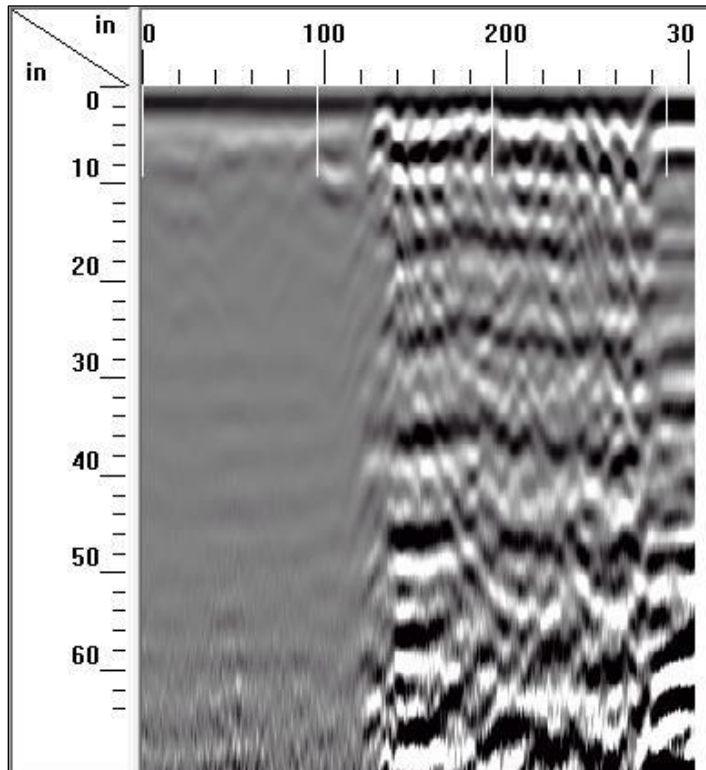
Another perspective of The Pizza Joint Downtown.

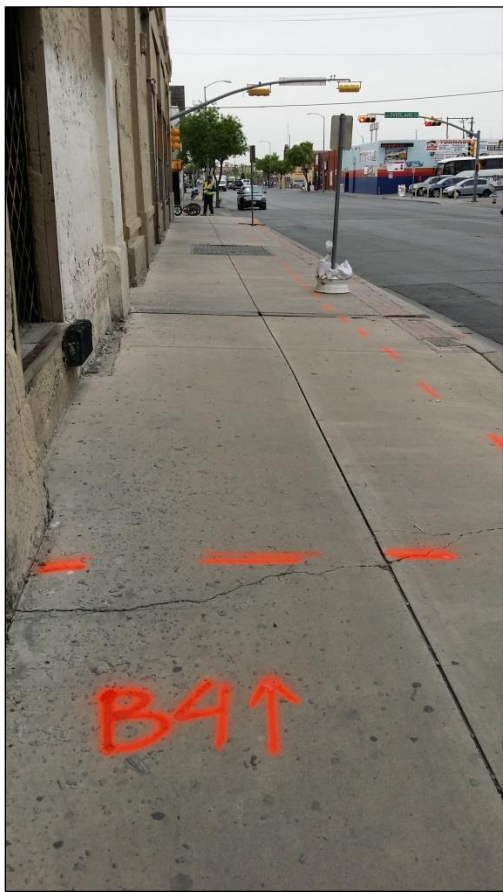
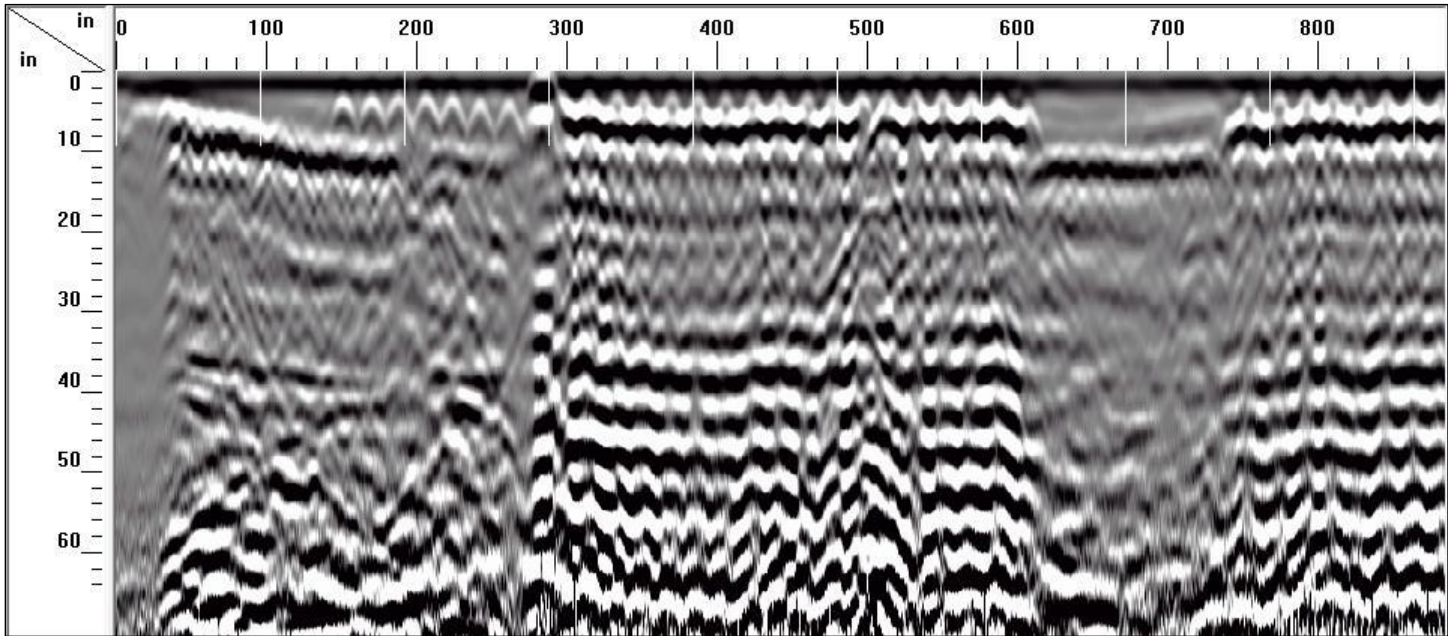
200 S Santa Fe St.

This reaction spans the entire building and extends to approx.. 2' off the curb.

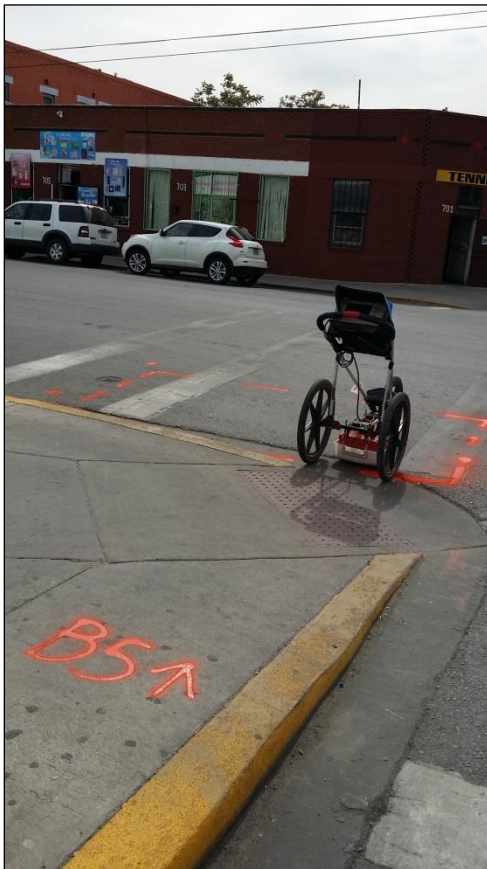
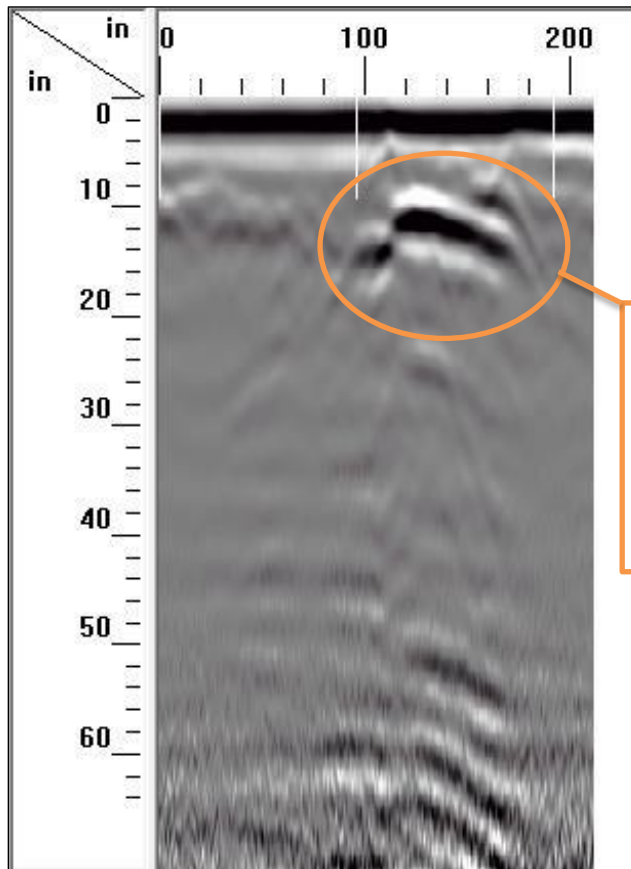
SE intersection of S Oregon St and Father Rahm Ave.

This reaction could simply be an area of washout below the asphalt, but it could also be a buried utility vault.

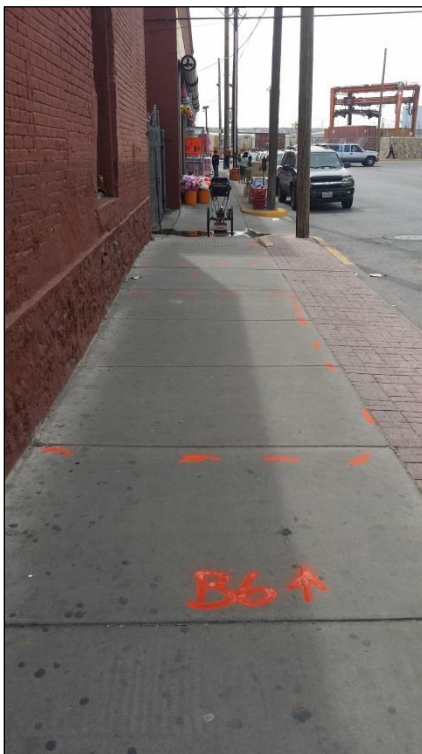
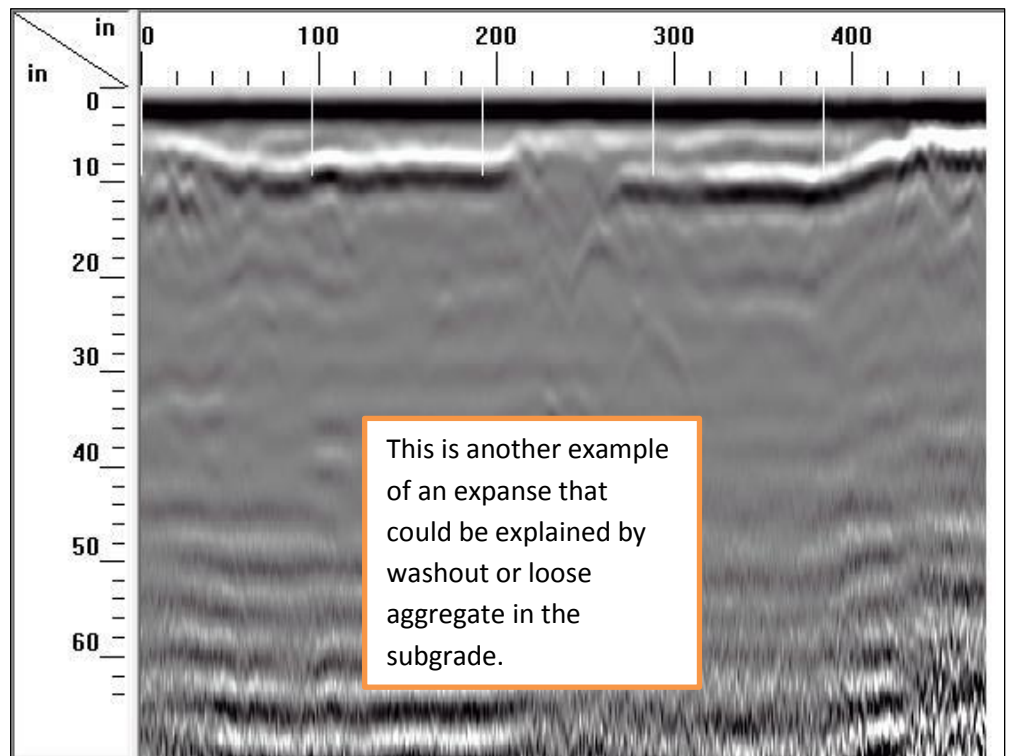
100 Block of Father Rahm Ave.

This is another example of an expanse that could be explained by washout or loose aggregate in the subgrade.
